MOMENTUM True Wireless

Workaround solving Android 10 Bluetooth connection problem (Cross key problem)

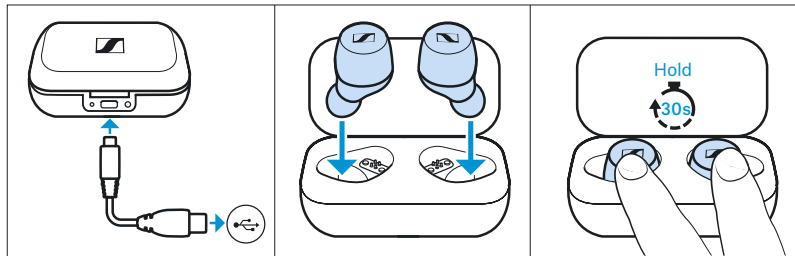
There is a known issue with Android 10 that the smartphone is not able to connect via Bluetooth with the Sennheiser MOMENTUM True Wireless after performing a firmware update.

1. Open the Bluetooth settings menu of your smartphone and remove the „MOMENTUM TW“ from the Bluetooth device list.
2. Open the Sennheiser Smart Control app and remove the „MOMENTUM TW“ from the device list.
3. Close the Smart Control app (not only hide).
4. Reset the earphones to the factory default settings
 - Make sure that the contacts on the earbuds and in the charging case are clean and make contact (the LED of the charging case lights up when you insert the earbuds into the charging case). If necessary, clean the contacts.
 - Use the USB cable to connect the charging case to a power source.
 - Insert the earbuds into the charging case and, within 60 seconds, touch and hold the right and the left touch control panel for at least 30 seconds.

The earphones are reset to the factory default settings.
